FATALITY NARRATIVE

Ironworker Killed When Rebar Cage Collapses*

Release Date: April 12, 2011
Incident Date: February 19, 2009
Case No.: 09WA01101
SHARP Report No.: 71-100-2011

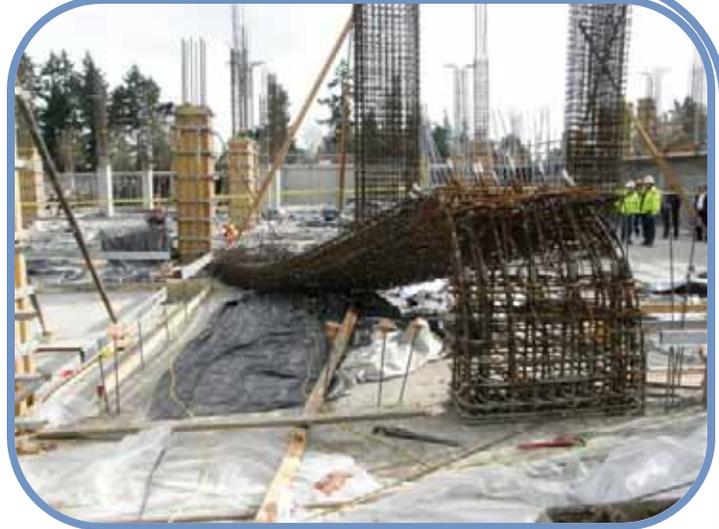
On February 19, 2009, a 23-year-old journey level ironworker died when a rebar cage collapsed. The victim worked for a structural steel erection contractor. The contractor was hired to perform steel rebar assembly and installation on the site of a new commercial office building. The job site work crew was erecting a steel rebar cage weighing about 5,600 lbs as part of a column structure. It measured 20x56 inches and 30 feet tall. They had previously erected 11 similar cages. The rebar cage was braced using 2x4's nailed together and attached to the building floor. A tower crane placed the cage into position and then released the cage. The victim and another crew member were climbing the cage to make adjustments to the rebar and set the braces. Both workers had fall protection gear and were working on the same side of the cage when the crew noticed the cage began to lean. The crew attempted to reconnect the crane to the cage, but before they were able to one of the 2x4 braces failed and the cage collapsed. The victim was struck by the falling rebar cage and died of blunt force injury of the head at the scene. The other worker escaped without injury.

- ! Ensure that reinforcing steel for columns, walls, and similar vertical structures is guyed or supported to prevent collapse. See [WAC 296-155-680](#)
- ! Make sure your accident prevention program (APP) addresses hazards and abatement methods when installing reinforcing columns, walls, and similar vertical structures. See [WAC 296-155-110](#)
- ! Ensure that the inspection of rigging and equipment is done by a qualified rigger. See [WAC 296-155-329](#) and [WAC 296-155-330](#)

- ✓ Use bracing that is in good working order. Frequently inspect and replace defective equipment and material.
- ✓ Make sure that bracing and guying are able to support the forces imposed.
- ✓ Ensure that loads are secured and will not inadvertently become displaced when released.
- ✓ A qualified person should design methods of bracing reinforcing steel when being placed into position.
- ✓ A competent person should determine if additional methods must be used to support reinforcing steel beyond guying and bracing.
